MOODY STREET DAM
MA 00345

PHASE I INSPECTION REPORT
NATIONAL DAM INSPECTION PROGRAM

Identification No.:	MA 00345
Name of Dam:	Moody Street
Town:	Waltham
County:	Middlesex
State:	Massachusetts
Stream:	Charles River
Date of Site Visit:	6 December 1978

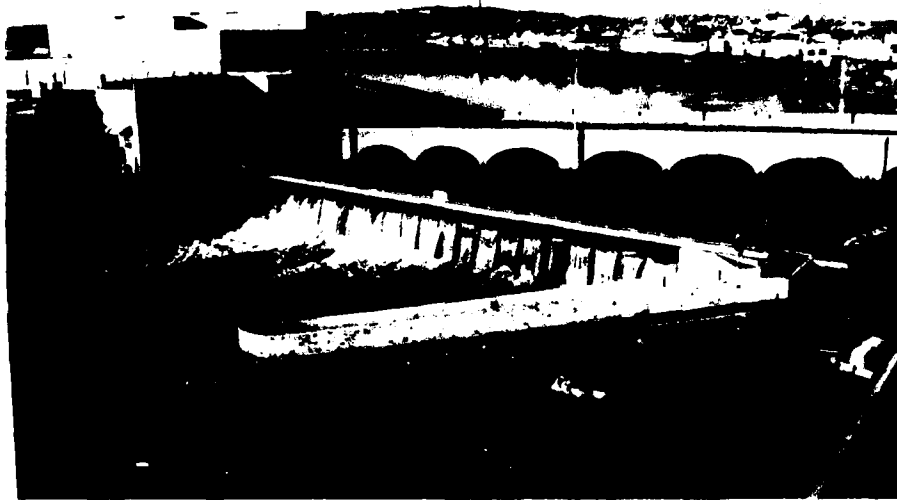
1. Overview of Moody Street Dam

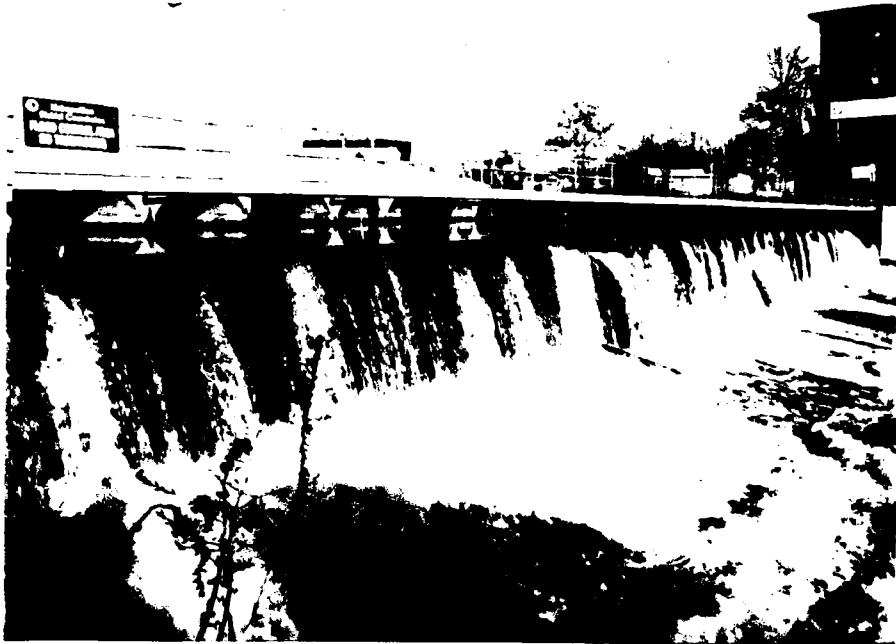
b. Dam. The spillway weir is constructed on granite masonry and is apparently founded on glacial till. A complete examination of the weir was not possible due to flow of water, Photos No. 1, 2, 3 and 4. The downstream apron was not visible. There is apparently no means to lower the water level below the spillway crest.

3. Spillway viewed from right bank

2. Examine the dam at a time when there is low flow to assess the condition of the granite masonry spillway weir, the downstream apron and the flashboards.
3. Assess the potential vulnerability of the dam to seismic events by conventional equivalent static load methods.

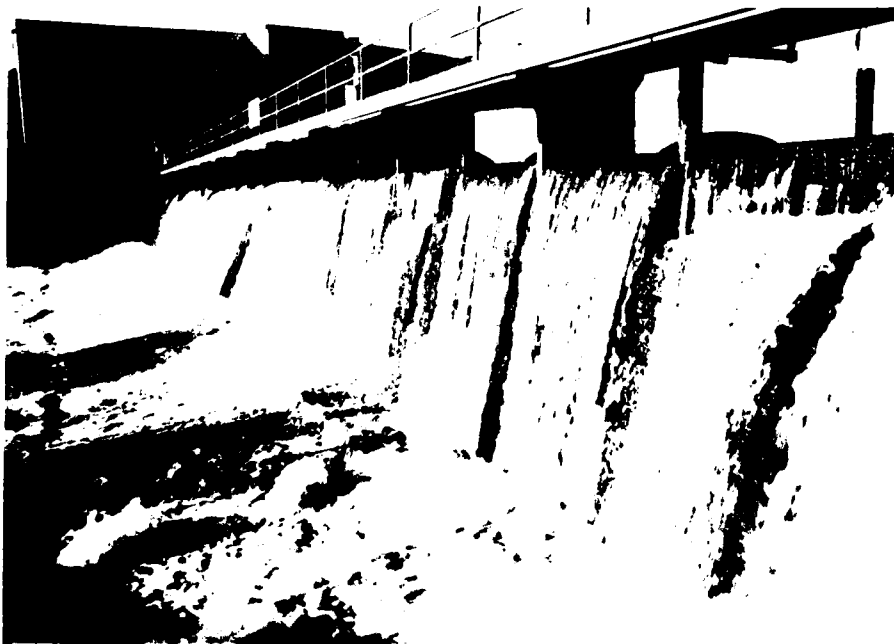
4. Spillway viewed from left bank
